SECURITY ASSESSMENT

100 BLACKS IN LAW ENFORCEMENT WHO CARE - ESB Security Assessment

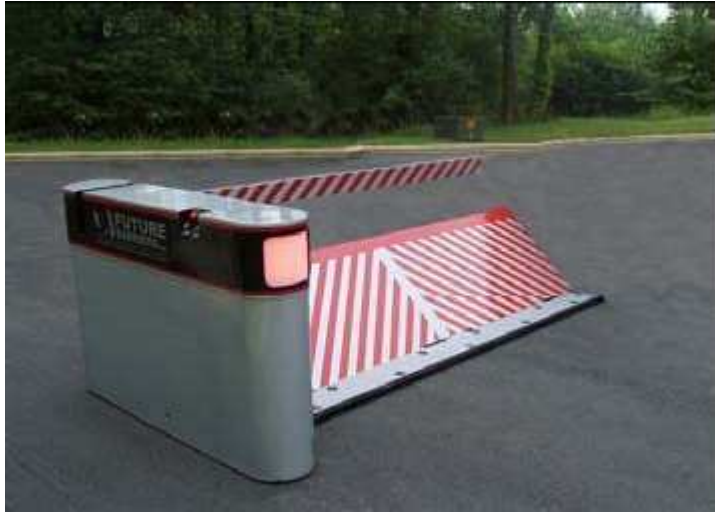
Surface Mounted Barrier

Observation: The loading dock is located on 33rd Street west of 5th Avenue, at the end of the building line. There are no physical barriers to stop a Vehicle Bourne Improvised Explosive Device (VBIED) from backing into the loading dock. If a VBIED detonates in the loading dock much more damage will be done to the building than if detonated by the curbside.

Recommendation: A crash rated cable arm, hydraulic bollards or surface mounted barriers should be installed to physically stop trucks from entering the loading dock until it is cleared with security.
